The Crack and Seat Method of Pavement Rehabilitation

Final Report

PHYSICAL RESEARCH REPORT NO. 104 / JULY 1988

Illinois Department of Transportation
Bureau of Materials and Physical Research

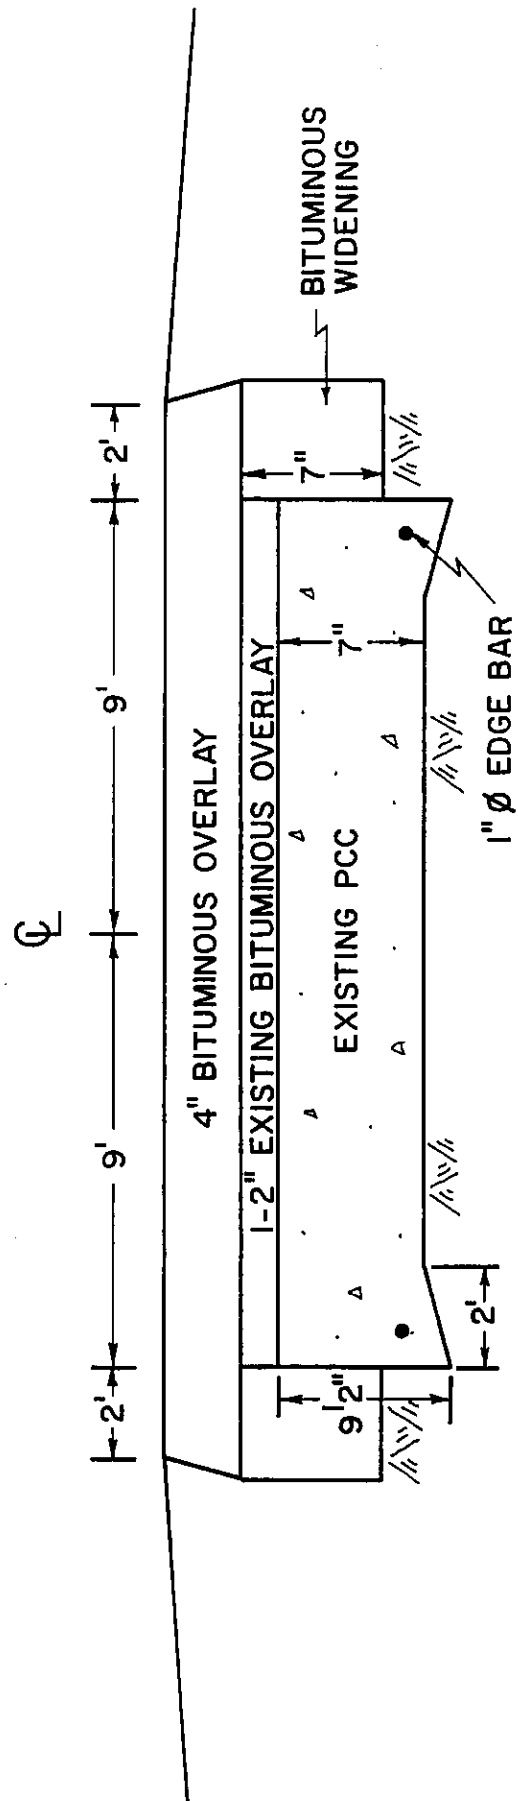
FIGURE 2: LINCOLN TRAIL CRACK AND SEAT CROSS SECTION

Originally constructed 55 - 65 years ago, Lincoln Trail featured a 9 1/2 - 7 - 9 1/2 thickened edge design with 1-inch diameter edge bars. A 1 - 2-inch asphalt overlay placed in the mid 1950's was badly deteriorated. The overlay remained in place during the cracking operation, but soil adjacent to the pavement was removed at several locations to verify full-depth cracking. A spring arm hammer was used to crack the pavement. After seating the pavement with 2 - 3 passes of a 50-ton rubber tire roller, a few soft spots were discovered, marked and patched. Traffic was allowed on the pavement prior to placement of a 4-inch asphalt overlay. The pavement cross section is shown in Figure 2.

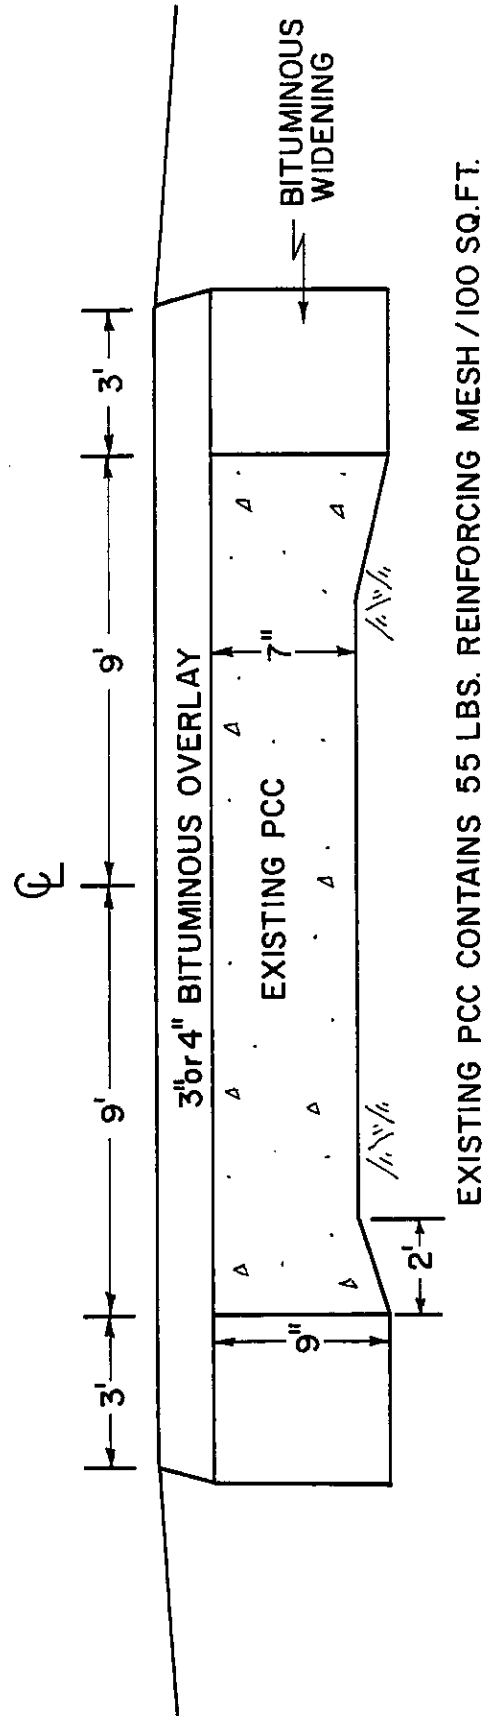
FIGURE 3: ILLINOIS ROUTE 97 CRACK AND SEAT CROSS SECTION

55 pounds of reinforcing steel per 100 square feet of pavement. Route 97 was bare at the time of cracking and seating and virtually every joint and the majority of cracks were badly spalled and deteriorated. The cross section for Illinois Route 97 is shown in Figure 3. Cracking was accomplished with a spring arm hammer and rolling with a 50-ton rubber tire roller. The pavement was watered to check the crack pattern. Rolling produced no soft spots, and therefore no patching was required.

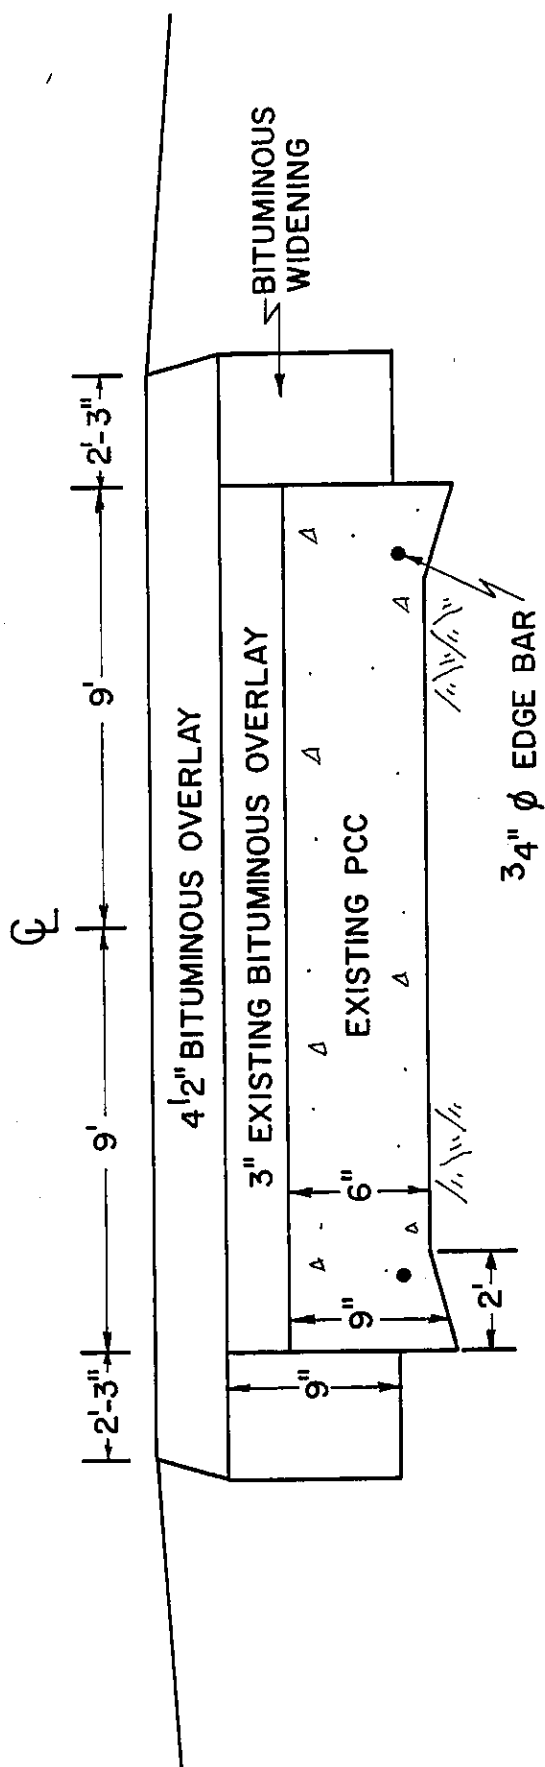
FIGURE 4: ILLINOIS ROUTE 101 CRACK AND SEAT CROSS SECTION

Illinois Route 101 was built in 1929. It was a 9 - 6 - 9 thickened edge pavement with 3/4-inch diameter edge bars. A badly deteriorated 3-inch asphalt overlay put down in 1960 was left in place, but a number of test strips were removed to verify that full-depth cracking had occurred. Figure 4 details the cross section of Illinois Route 101. A spring arm hammer was used to crack the pavement and 2 passes of a 50-ton rubber tire roller were made to seat the pavement. Approximately 2% of the pavement required patching after rolling.

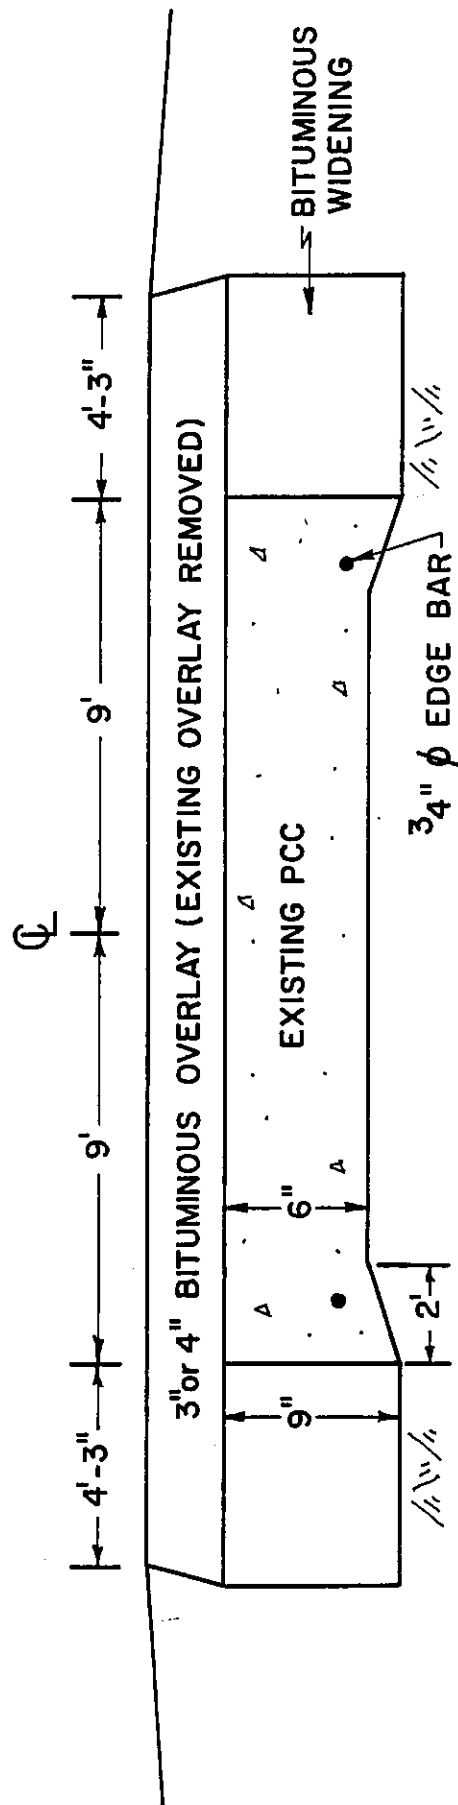
FIGURE 5: ROCKTON ROAD CRACK AND SEAT CROSS SECTION

Originally constructed in 1932, Rockton Road was a 9 - 6 - 9 thickened edge pavement with 3/4-inch diameter edge bars. Joint spacing was 30 feet with every third joint an expansion joint and contraction joints between. The existing asphalt overlay was removed prior to cracking and seating, revealing badly deteriorated joints. The pavement cross section is detailed in Figure 5. This pavement was also cracked with a spring arm hammer and seated with three passes of a 50-ton rubber tire roller. No pumping or soft spots were observed.

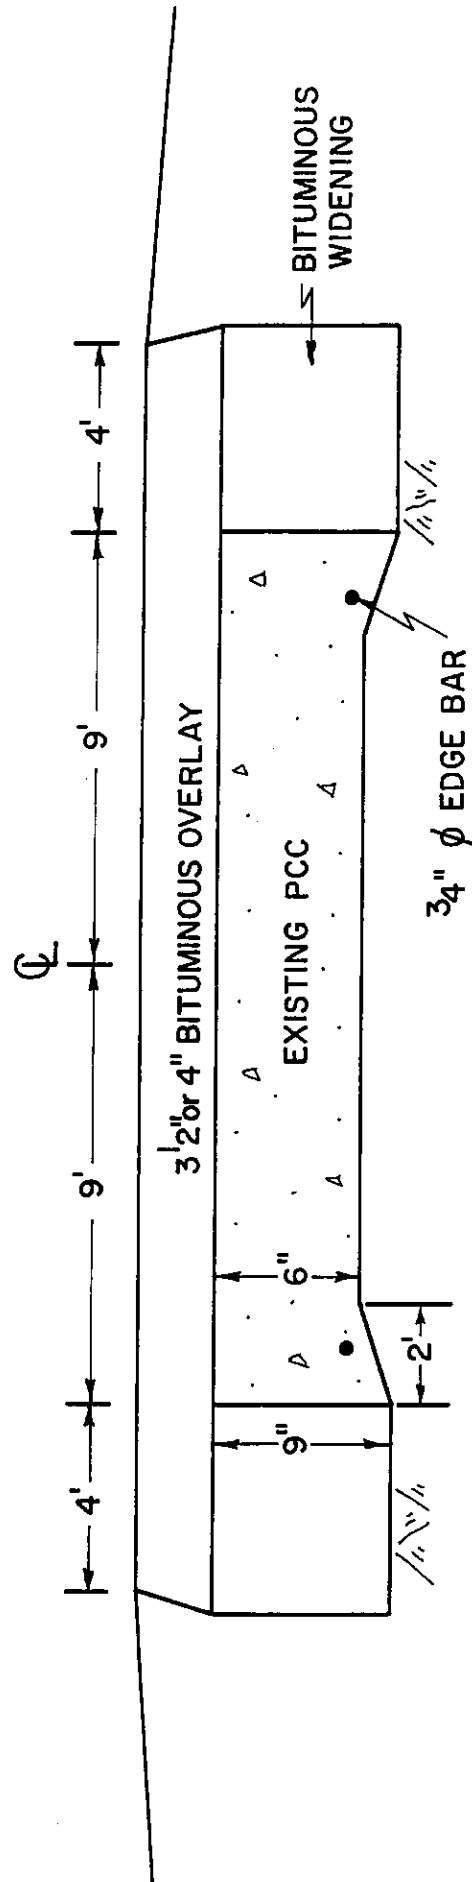
FIGURE 6: U. S. ROUTE 6 CRACK AND SEAT CROSS SECTION

Constructed in 1924, this pavement was a 9 - 6 - 9 thickened edge design with 3/4-inch diameter edge bars. The pavement was bare at the time of cracking and seating and was badly cracked and settled. The cross section for U. S. Route 6 is shown in Figure 6. The pavement was cracked with a spring arm hammer and seated with 1 - 2 passes of a 50-ton rubber tire roller. Soft spots were patched with asphalt concrete prior to overlaying.

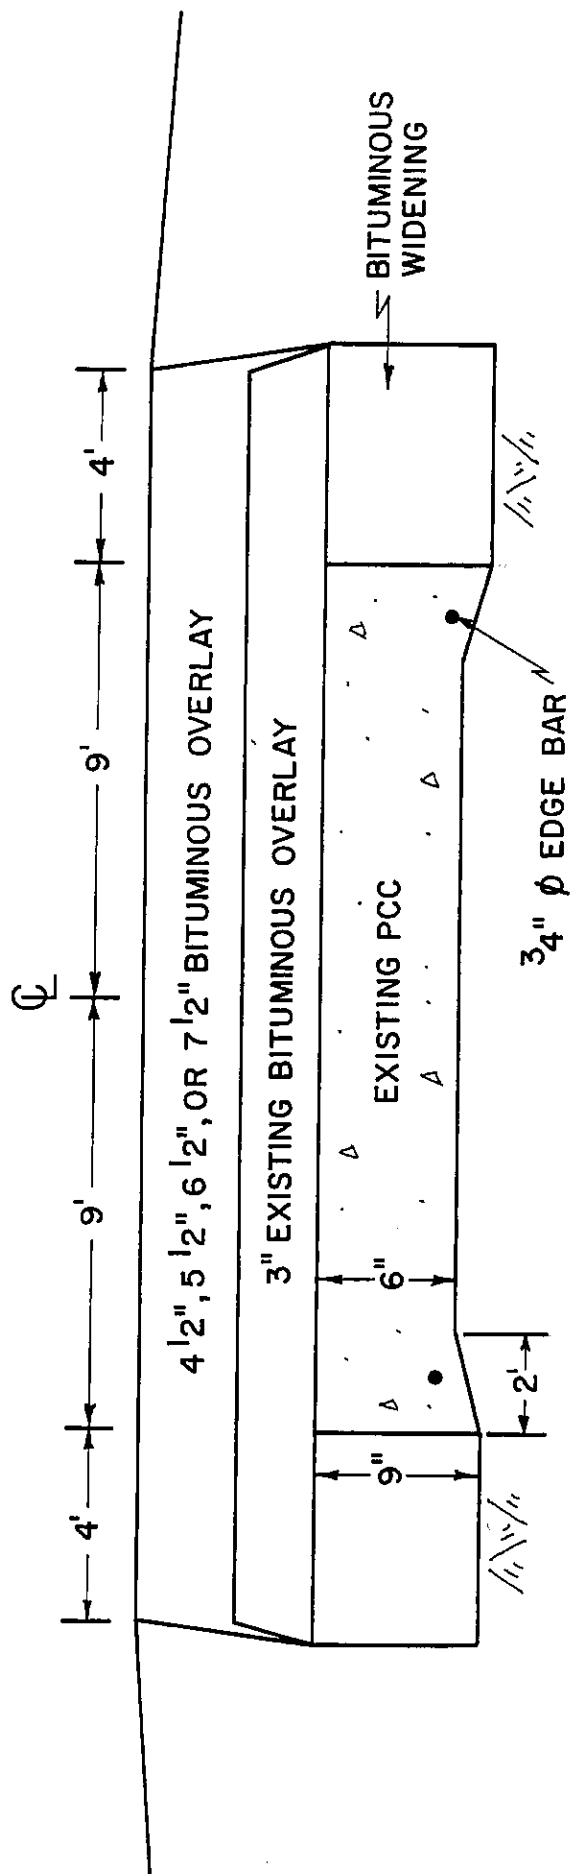
FIGURE 7: ILLINOIS ROUTE 99 CRACK AND SEAT CROSS SECTION

The original pavement was constructed in 1933 and was a 9 - 6 - 9 thickened edge pavement with 3/4-inch diameter edge bars. The pavement had been overlaid in 1970 with 3 inches of asphalt concrete. The cross section is shown in Figure 7. Heavy coal truck traffic had caused serious damage to the pavement. The overlay remained in place, but portions were removed to verify full-depth cracking. Unlike the other sections, this pavement was cracked with a guillotine hammer. The pavement was watered to check the crack pattern. Two passes were made with a 35-ton rubber tire roller to seat the pavement. Rolling produced

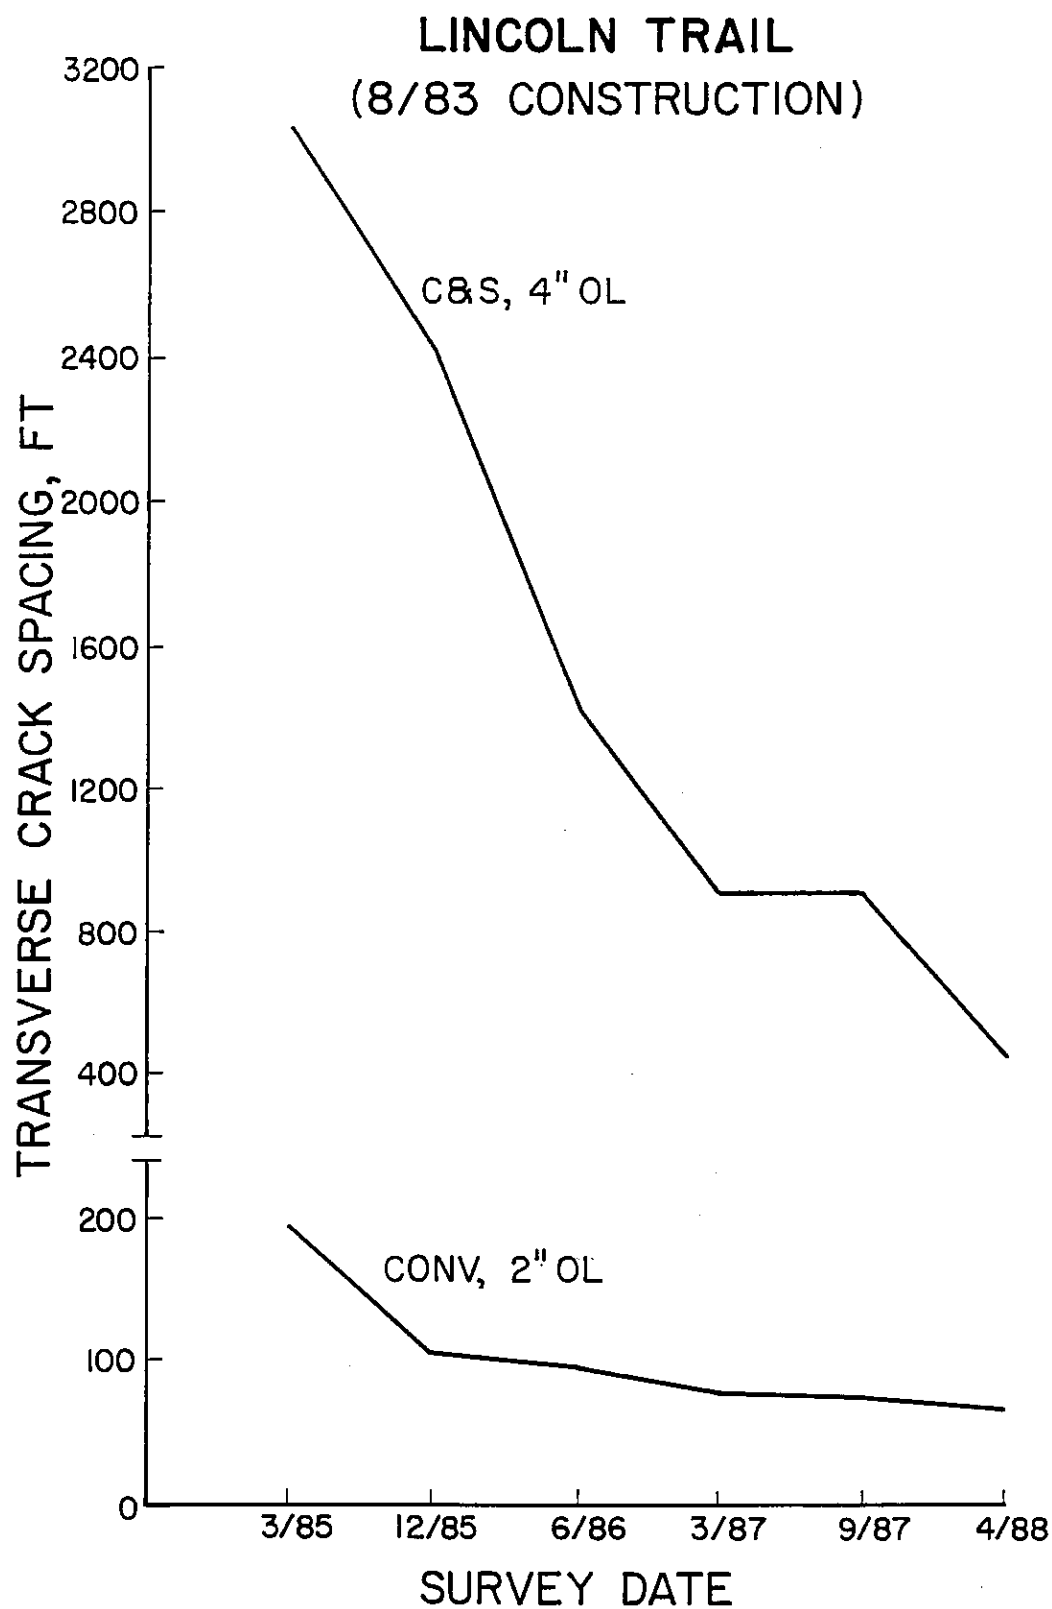
FIGURE 8: TRANSVERSE CRACK SPACING VS. TIME FOR LINCOLN TRAIL

After five years in service, the crack and seat section seems to be performing well. While not directly comparable to the control section due to differences in overlay thickness, cracking and seating did significantly reduce the amount of transverse cracking, as can be seen in Table 2 and Figure 8. There was a slight increase in the amount of longitudinal cracking shown in Figure 9, which may be attributable to the type of pavement breaker used and the crack pattern it produced. Other states have noted that continuous longitudinal cracking should be avoided due to its tendency to reflect through the overlay (2). Prior to the last survey, all the cracks had been routed and sealed.
